MIRROR LAKE MONITORING: WATER LEVEL OBSERVATIONS AND GROUNDWATER-SURFACE WATER INTERACTIONS

Undergraduate Senior Research Thesis

At The Ohio State University

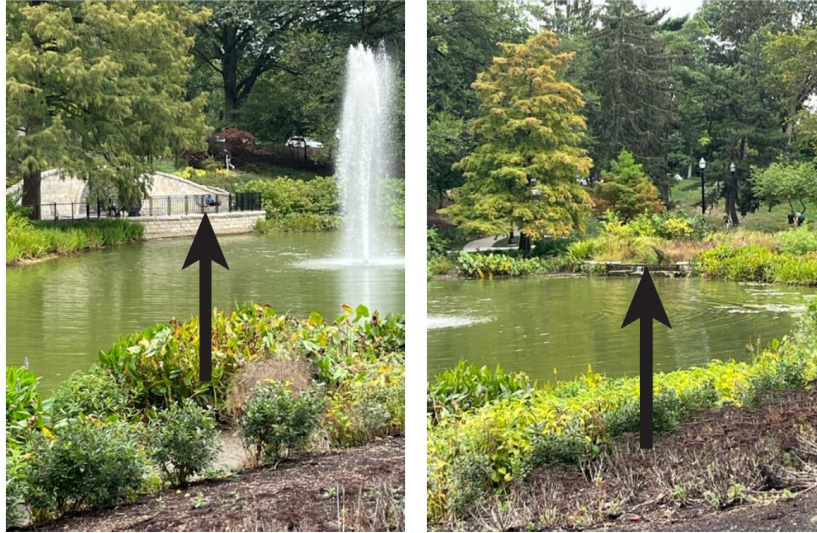
Figure 5: Photographs of the stone patio overlook (left) and eastern weir (right) where lake levels were measured from fixed reference points (indicated with arrows).

Depth to water was measured approximately every month from July 2020 to July 2021 in all accessible piezometers (Figure 4). To make a measurement, piezometer caps were opened with a 14 mm socket wrench, the beep tape was lowered, and depth to water was measured from the top of the PVC casing. Changes in lake level were also assessed by measuring the distance from the lake surface to two fixed reference points located at the eastern weir and the stone patio of the overlook (Figure 5). Approximate error for all water level measurements is 0.5 cm.

Appendix B: Measured depths to water on 13 dates. All depths are relative to coordinates shown. For piezometers, coordinates refer to the top of casing. Lake reference points are indicated in Figure 4 (Lake 1 is the top of the center stone paver on the left photograph, and Lake 2 is the top of the corner of the weir on the right photograph). “n.d.” indicates no data due to inaccessibility (snow, etc).

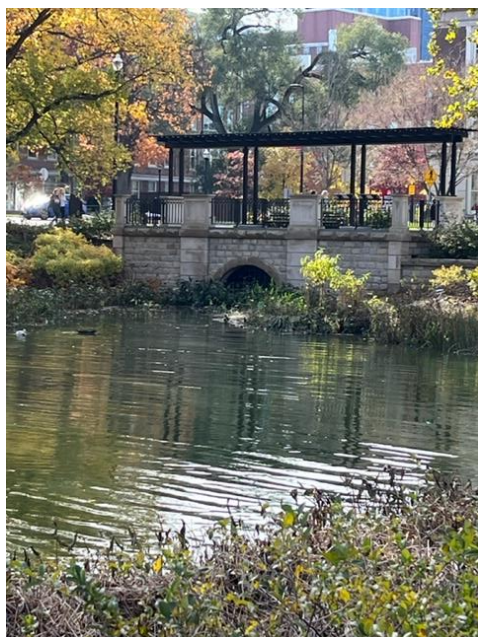
Figure 9: Photograph of a gate connected to the storm drain on the west side of Mirror Lake.

At Mirror Lake, the inferred ground flow northwest towards Neil Avenue is consistent with discharge to an area of lower elevation, possibly a storm drainage network. A campus map of subsurface infrastructure confirms that a storm drain indeed runs underneath Neil Avenue (personal communication, Ruth Miller). A portion of the storm drain is visible on the western side of Mirror Lake (Figure 9). Stormwater systems often receive groundwater discharge, as they are designed to divert water out of cities, while public drinking water networks often lose water to the surrounding aquifer, as they are pressurized to deliver water to users (Kaushal and Belt, 2012). Together, this integrated network of water pipes forms the urban karst system in heavily developed regions like The Ohio State University campus. When pipes are laid, the ground is trenched, and the trenches are backfilled. These backfill materials also influence groundwater exchange with storm drainage networks and can create additional hydrologic flow paths within the urban karst structure.

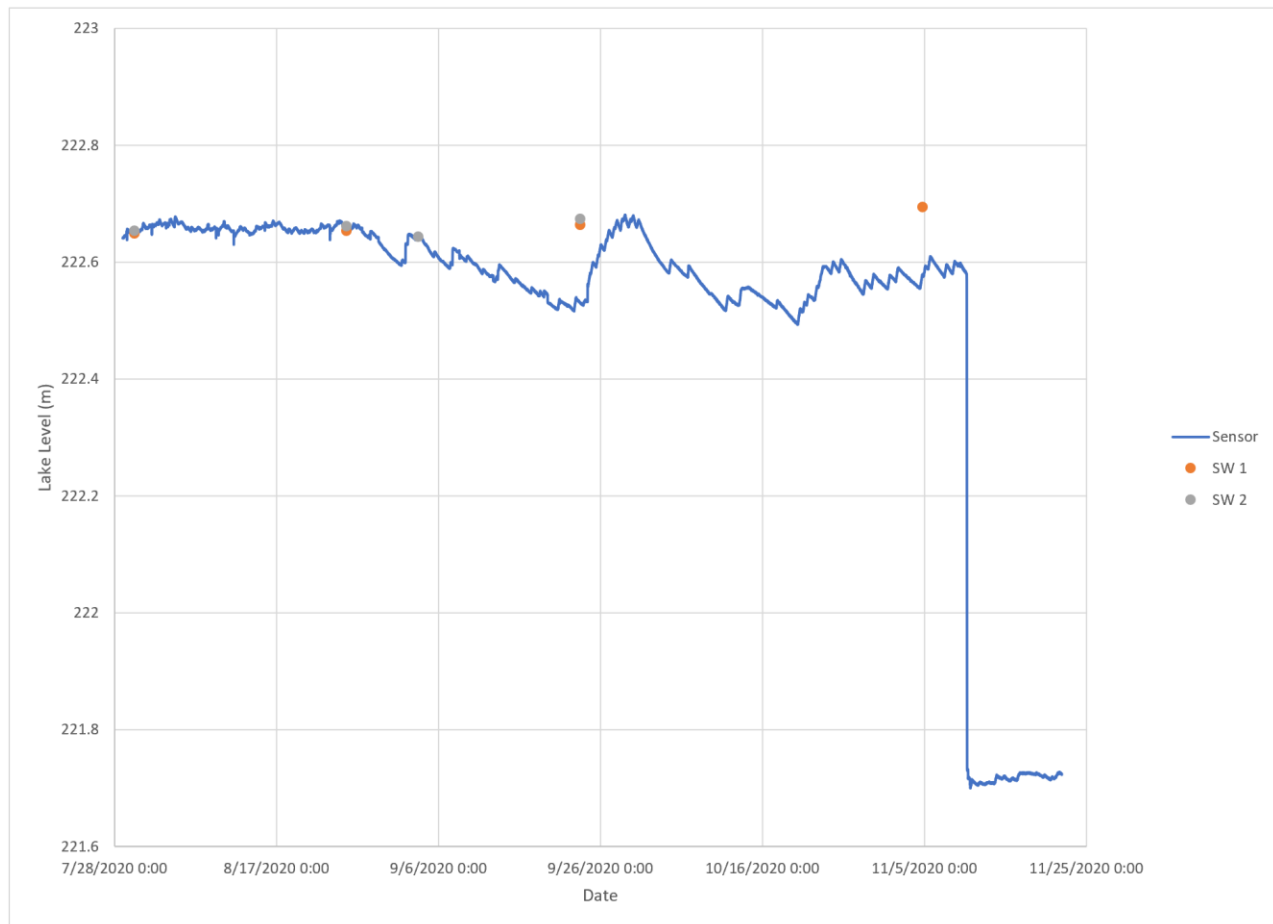
Appendix D: Recorded water levels showing sensor data and hand measurements. Sensor data became unreliable due to battery failure in September 2020, and logging ceased in November 2020.

Water level, temperature, and conductivity sensors in the deep monitoring well and lake were replaced in the summer of 2021 and fall of 2021, respectively, due to battery failure. The record of water depth from Mirror Lake was converted to hydraulic head by comparing manual monthly measurements to determine the elevation of the sensor. The sensor elevation was then used to convert continuous water depths to lake surface levels (or hydraulic head). Unfortunately, the sensor only logged less than two months of reliable data before readings became unreliable due to dwindling battery power. The loss of fidelity began around September 19, 2020, and logging apparently ceased in November of 2020. Therefore, sensor data were only used to estimate the date when Mirror Lake was drained for the Ohio State-Michigan football game and the change in water level. It is important to note that no direct hand measurements could be made during this period, so the change in water level could not be vetted and may be inaccurate.
